City of Somerville — RFP nº 12-71

ADA Self-Evaluation (as basis for Transition Plan)

Prepared by
Institute for Human Centered Design
August 12, 2013

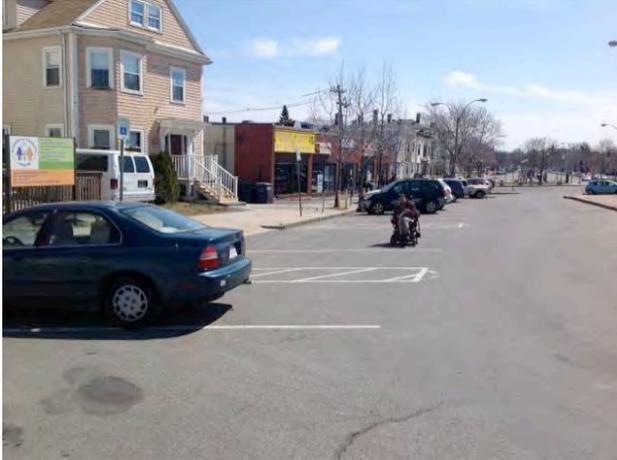
Photo 1

- No van designated space is provided
- Sign identifying one parking space closest to Somerville Avenue is missing

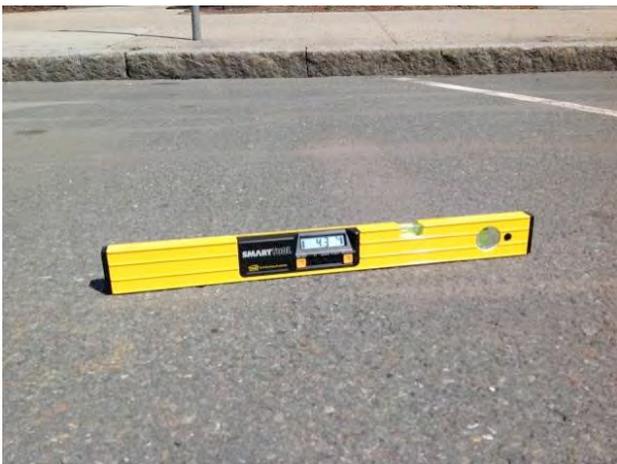
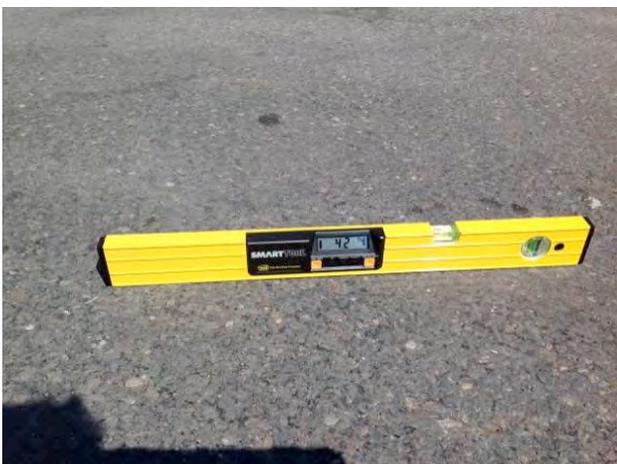
- No van designated space is provided
- Cross slope at 3% or more in the accessible spaces.

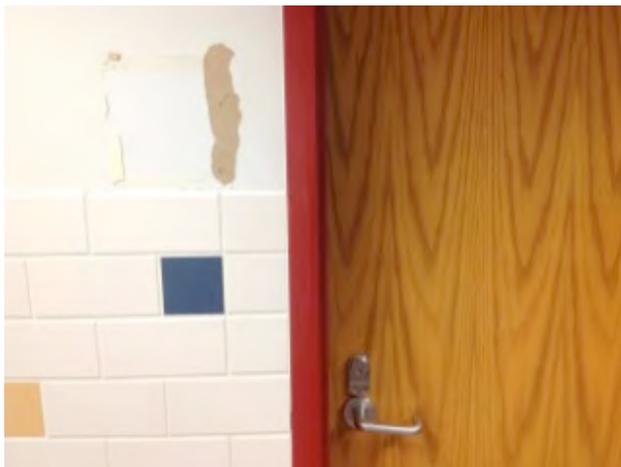
Photo 8 – Kennedy School

Some signs mounted on walls or glass surfaces can be difficult to find or read. These signs have reduced visibility as a result of font sizes that are too small, poor color contrast between the signs and walls or glass, and a general lack of coordination with both direct lighting sources and indirect sources such as solar glare. (Photo 8)

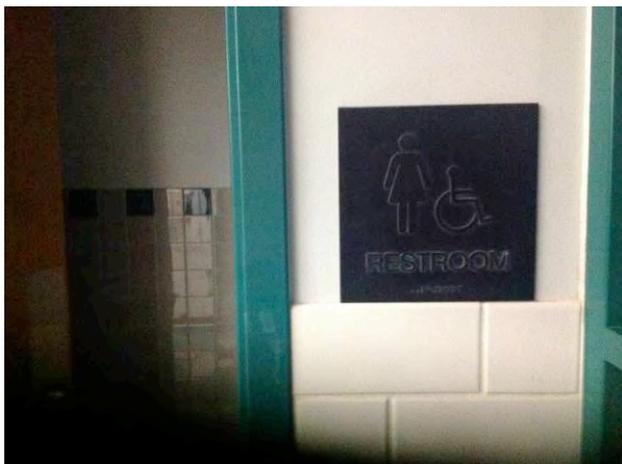
Photo 12 – Healey School

Or existing signage is handwritten or damaged (Photo 12).

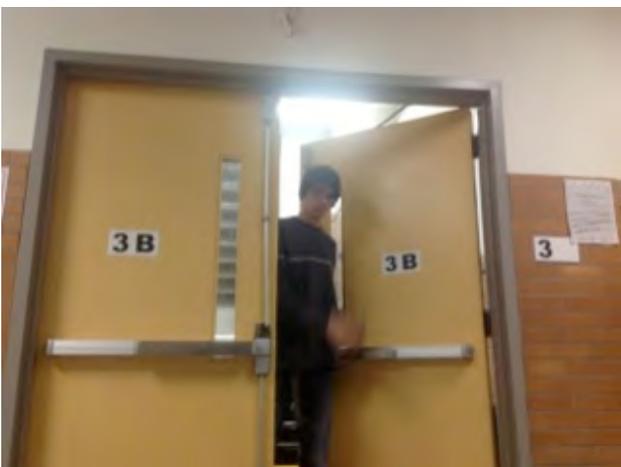
Photo 15 – High School

Some egress routes and fire exits are not identified by signage. (Photo 15)

Install tactile signs at all doors of egress stairs and all exit doors leading to the exterior of the building. Any exit that is not on an accessible route, e.g., the exit doors with a step into the terrace, must have a sign clearly indicating the location of the accessible entrance/exit.
